Wolf Creek Dam (Lake Rene).  
NDI I.D. Number PA-748. DER I.D.  
Number 17-108. Ohio River Basin,  
Wolf Creek, Clearfield County,  
Pennsylvania. Phase I Inspection Report.

PHASE I REPORT  
NATIONAL DAM INSPECTION PROGRAM

NAME OF DAM: Wolf Creek Dam  
STATE LOCATED: Pennsylvania  
COUNTY LOCATED: Clearfield  
STREAM: Wolf Run, a secondary tributary of Sandy Lick Creek  
DATE OF INSPECTION: April 4 and May 4, 1979

PHASE I REPORT  
NATIONAL DAM INSPECTION PROGRAM  
WOLF CREEK DAM  
NDI I.D. NO. PA-748  
DER I.D. NO. 17-108

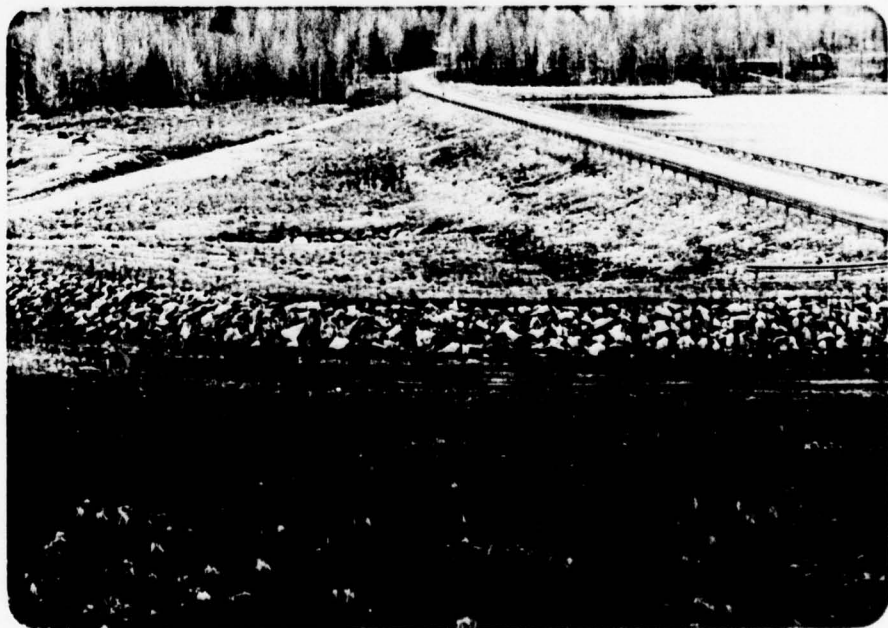
Downstream Face

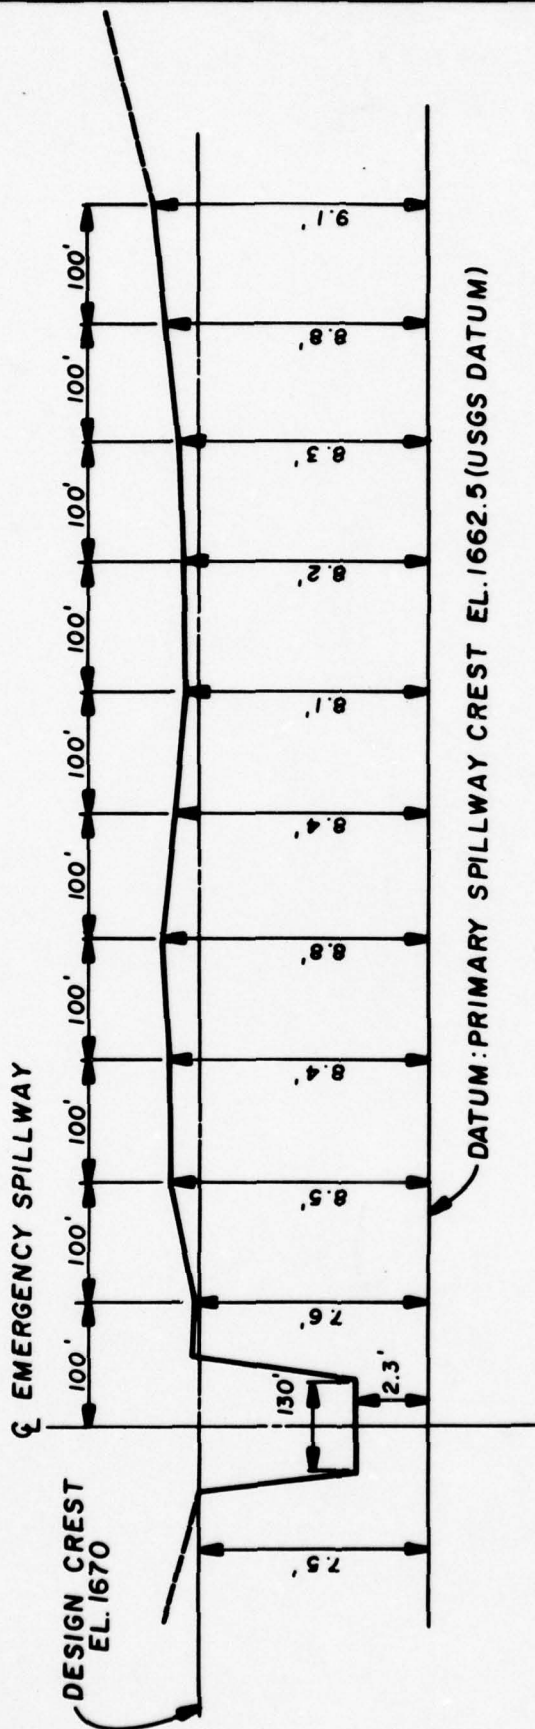
# **DAM CREST PROFILE** (LOOKING DOWNSTREAM)

The top of the embankment was surveyed relative to the pool level on the date of inspection, which was estimated to be at Elevation 1662.6, the spillway crest level (Elevation 1664.5), and the crest of the embankment was found to be approximately 0.7 to 1.0 foot above the design elevation of 1670. The dam crest profile is illustrated on Plate 8.

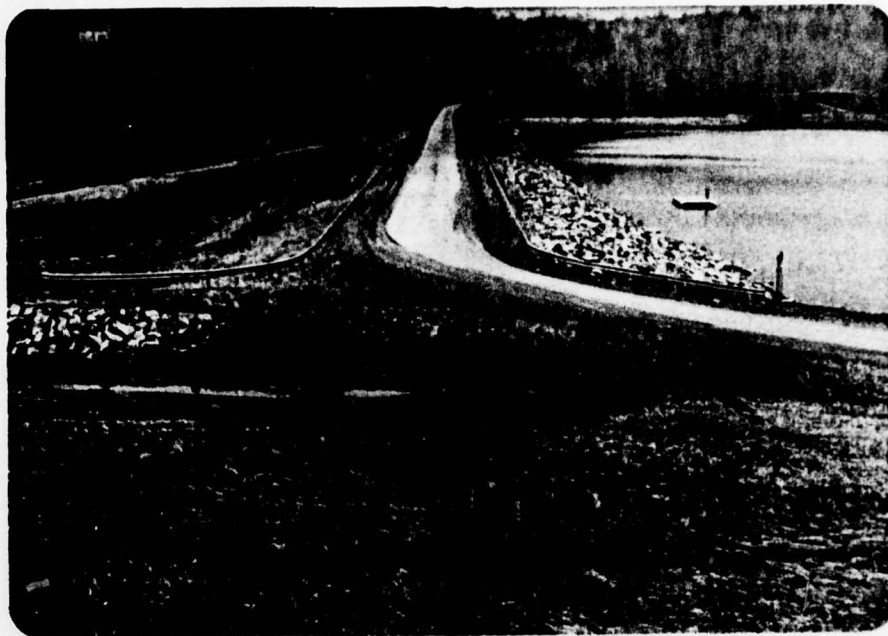
Photograph No. 1

Crest (looking north). Emergency spillway in foreground.

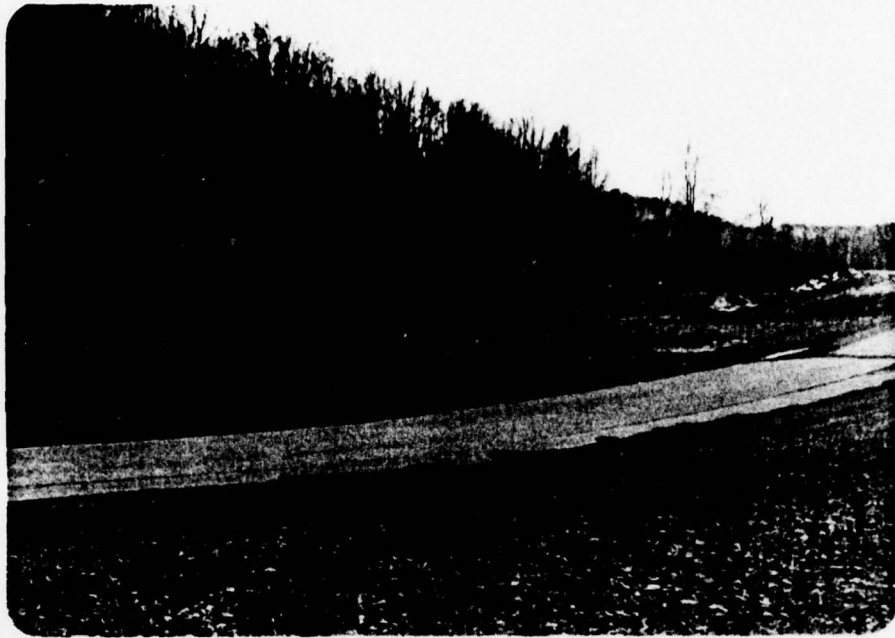
Photograph No. 3  
Emergency spillway discharge channel.

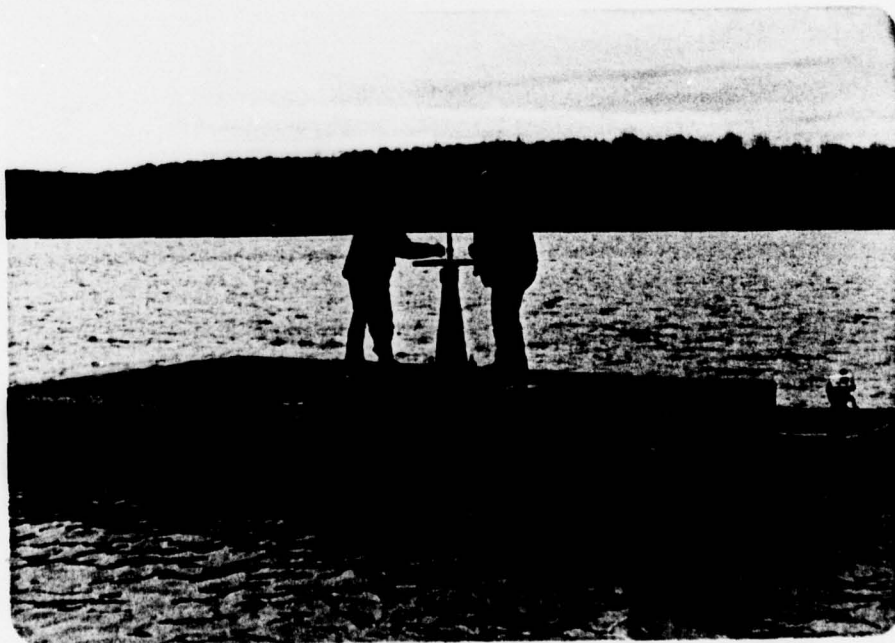
Photograph No. 4  
Primary spillway intake structure and outlet pipe  
sluice gate control.
